MEMORANDUM

To:	Valmichael Leos and Anne Foster U.S. Environmental Protection Agency	Date:	May 4, 2015
From:	John Laplante, John Verduin, Wendell Mears, and David Keith, Anchor QEA	Project:	090557-01
Cc:	Gary Miller, USEPA Philip Slowiak, IP David Moreira, MIMC		
Re:	Post-TCRA Semi-Annual Inspection Report – January/April 2015 Inspection

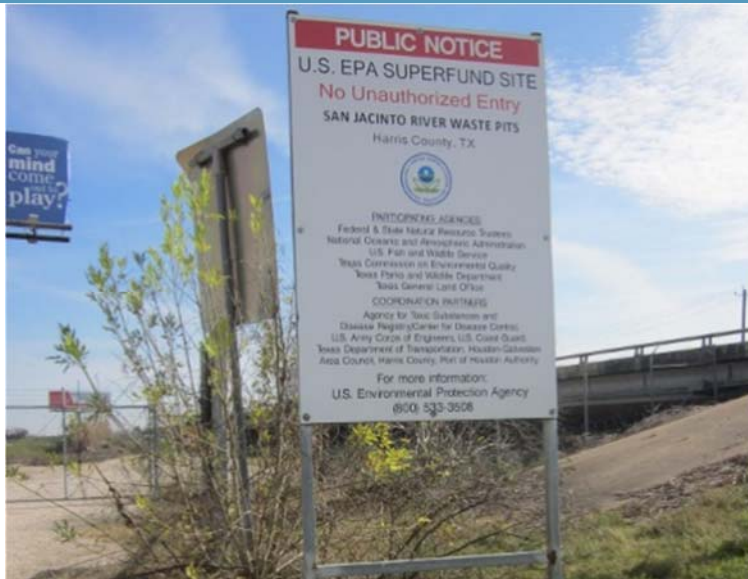
Three USEPA Public Notice signs are present around the TCRA Site located: 1) near the gate entry point for the perimeter fence north of I-10; 2) near a gate entry point south of I-10; and 3) at the end of the TxDOT right-of-way north of I-10 near the San Jacinto River. For examples, see Photographs 1, 5, and 15 in Appendix A. These three signs were observed to be in place and undamaged during the January 8, 2015 inspection.

Photograph 01: USEPA Public Notice Sign located outside the access gate north of I-10 (view southeast)

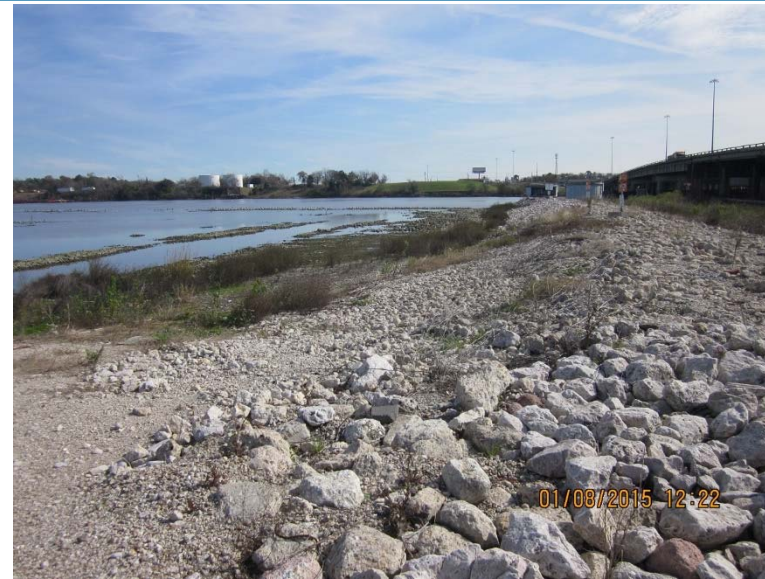
Photographs of the armored cap from the inspection event are provided in Appendix A (see photographs 2 through 12 and 19 through 20). All of the visible portions of the armored cap were observed to be intact, and no movement or erosion of waste materials into the San Jacinto River was observed at any location during the visual inspection.

A total of fifteen “Danger” and “No Trespassing” signs were installed at the TCRA Site around the perimeter of the land portion of the TCRA Site; the signs are mounted on steel posts and set in concrete pads. For examples, see Photographs 2, 4, 6 through 7, and 9 through 12 in Appendix A. These signs were observed to be in place during the visual inspection. These signs are intended to face the San Jacinto River to deter water-based entry to the TCRA Site. Several of these signs had rotated out of proper alignment due to the wind. The affected signs were re-aligned to the intended viewing perspective, and the screws fastening the signs to the steel posts were tightened.

Photograph 02: Warning signs and vegetation along southern berm (view east)

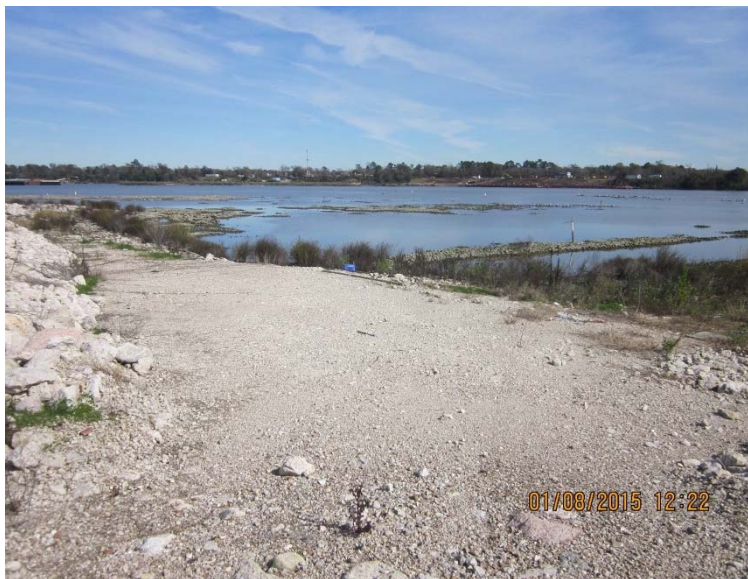
Photograph 03: Eastern Cell as viewed from intersection of southern and central berms (view northeast)

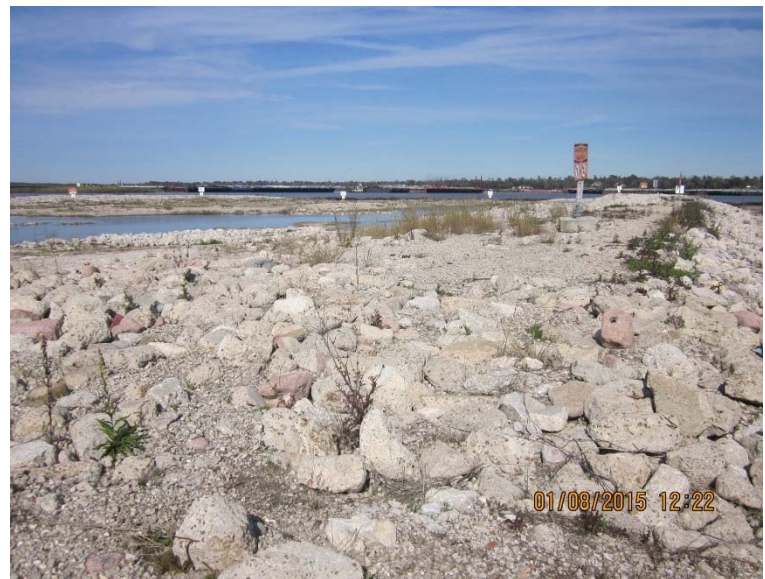
Photograph 04: Warning signs along perimeter and interior of Western Cell (view northwest)
